# Manhole Inspection Summary

Manhole # S33WW1011MH

**Location** Address: **213 UPNOR RD** Cross Street: **PURLINGTON WAY**

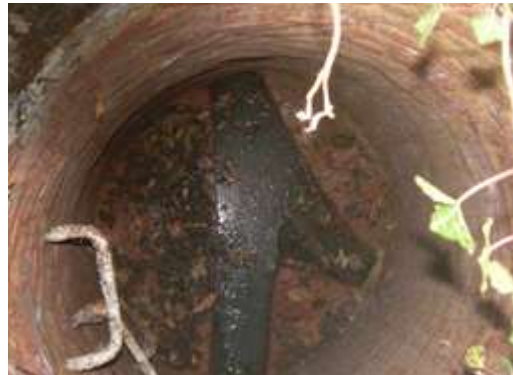
Top View

Frame leaks. Bench and Channel debris.

Comments **Flow was stagnant and slow - pipes may need to be cleaned.**

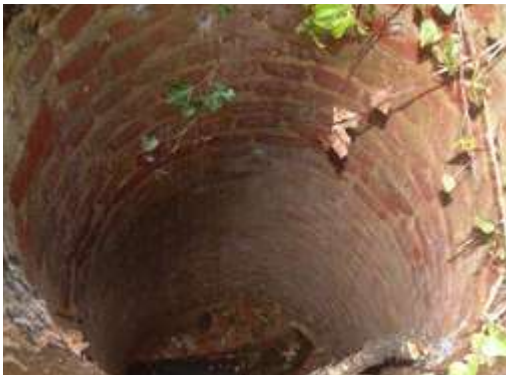
Defect

Adjustment deterioration and infiltration.  
Barrel infiltration - other side.

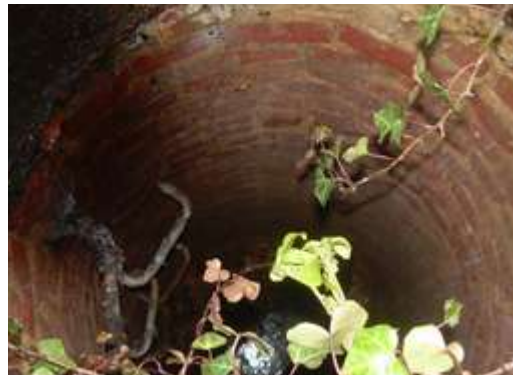
Defect

Adjustment deterioration and infiltration.  
Barrel infiltration.

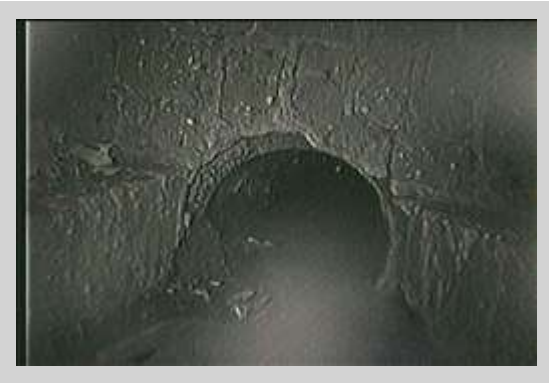
### 8 in. Circular Gravity Sewer Pipe Out @ 12 O'Clock

Invert Depth: **10.00** (ft.) Flow Characteristics: **Slow**

Infiltration: **Evidence** Pipe Seal Cond: **Unknown**

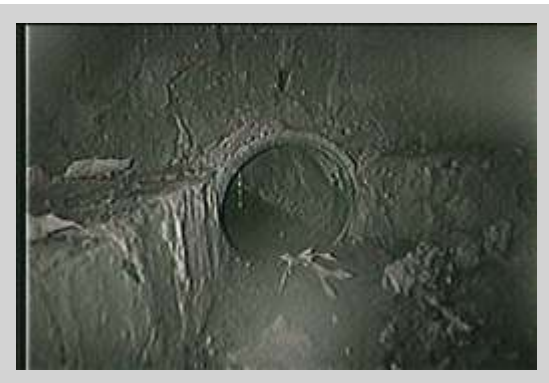
### 6 in. Circular Gravity Sewer Pipe In @ 4 O'Clock

Barrel deterioration and infiltration.

Infiltration: **Evidence** Pipe Seal Cond: **Unknown**

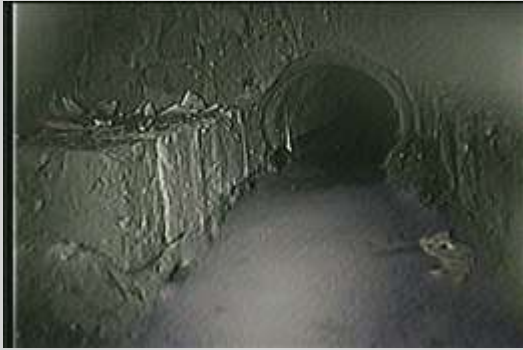
Pipe In @ 7 O'Clock

Invert Depth: **9.99** (ft.) Flow Characteristics: **Slow**

Infiltration: **Evidence**
